The landslides of the 8th November 2020 in the Gordon Town – Irish Town area of Jamaica: geology, triggers and consequences

ABSTRACT. Landslides are a major geological hazard induced by either earthquakes or high intensity rainfall causing damage to life and infrastructure. The Hope River Watershed in Jamaica is vulnerable to landslides due to its steep terrain and impermeable surface lithology. In 2020, Jamaica was impacted by two tropical storms, Zeta (October 19-25) and Eta (November 1-9), which triggered three landslides along the Gordon Town and Irish Town roads on the 8th November. Geological field mapping and rainfall analyses were undertaken to understand the trigger mechanism for the landslides. Detailed field mapping showed that one landslide (L1) occurred in colluvial deposits, one (L2) in jointed Wag Water conglomerates, and one (L3) in interbedded sandstones and shales of the Wag Water Formation. Two of the landslides (L1 and L3) occurred through failures of slopes above the roadway, while L2 was caused by a failure below the roadway. Rainfall analysis shows that the total rainfall for the seven days of TS Zeta was 1841 mm. The station at Mavis Bank recorded the highe

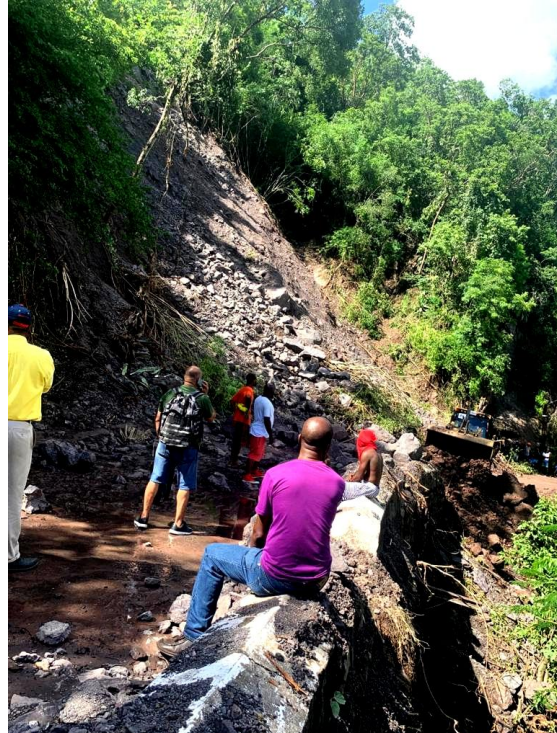
Figure 3. Landslide **L1**. This is situated in old landslide deposits. Photograph courtesy of Prof Ralph Robinson.

Landslide L1 (Figure 3). This landslide occurred on the Kingston to Gordon Town Road a little to the NE of the Junction with the Irish Town Road (18° 02.000' N, 077° 43.948' W). This landslide occurred within colluvial deposits related to previous landslides. The colluvium consists of unstratified, poorly sorted sand, pebbles and boulders. This landslide represented movement within unconsolidated material from previous landslides.

through failures of slopes above the roadway, whereas **L2** was caused by a failure below the roadway. The roadway at **L1** was cut in unconsolidated colluvial material, whereas that at **L3** was cut through interbedded sandstones and shales of the Wag Water Formation with a fold plunging towards the roadway down a valley. Both **L1** (colluvial material) and **L3** (interbedded sandstones and shales) have a lithological component that caused the landslides, whereas **L3** also had a structural component. For **L2**, it is possible that river erosion (over hundreds of years) led to slope steepening; yet it is clear that structure (joint orientations) was the main geological control on slope failure.

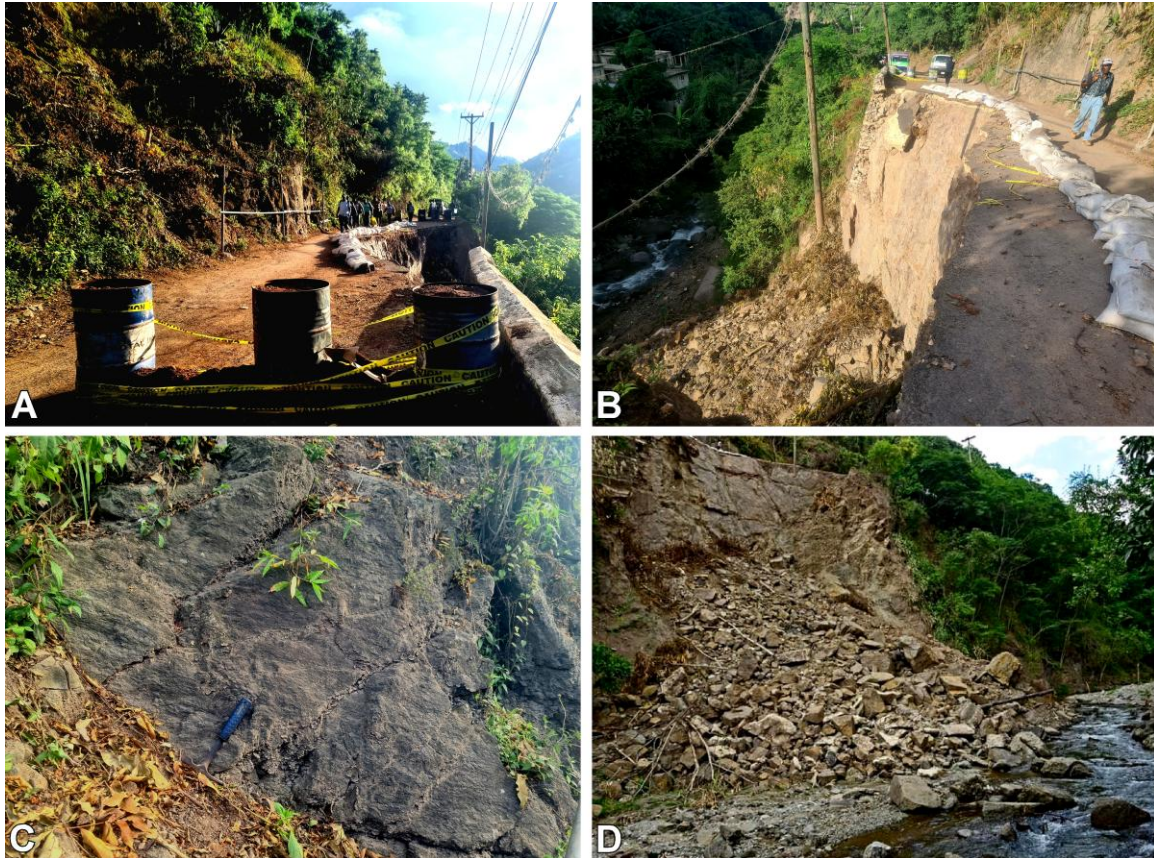
Figure 4. Landslide L2 – failure in jointed conglomerates of the Wag Water Formation. **A.** view along the road towards Gordon Town showing the breakaway. **B.** view looking down into break away. **C.** joint surface (with slickensides) exposed along the road. **D.** view of landslide deposit at foot of break away. Photographs taken SFM.

Landslide L2 (Figures 4–5). This occurred on the Kingston to Gordon Town Road about 1 km to the NE of the Junction with the Irish Town Road (18° 02.090' N, 077° 43.610' W). This landslide is a series of rock falls affecting jointed bedrock of the Wag Water Formation (Figure 4). The rock consists of very thickly bedded, pebble conglomerates and breccias. Although bedding is poorly developed (6 orientations were measured), joints and minor faults with slickensides are developed in semi-regular systematic sets. Three joint/minor fault sets can be identified: **J1** has a strike of 120 (NW–SE) and dips at 70° to the SW; **J2** has a strike of 060 (ENE–WNW) and dips and is vertical; and **J3** has a strike of 170 (N–S) and dips at 50° to the SW (Figure 5). Joint sets **J2** and **J3** are aligned such that they could represent a conjugate set related to the principle stress direction (σ_1) related to simple shear associated with the E–W sinistral strike-slip deformation in Jamaica related to its position on the northern part of the Caribbean Plate (DeMets and Wiggins-Grandison, 2007). The three-dimensional interaction of these two joint sets produces rock wedges that are elongated in a downslope direction, and the joint surfaces that are exposed in the landslide failure surface (Figure 4D) indicate that this landslide was a bedrock wedge failure. The failure

destroyed half of the road (Figure 4A) preventing vehicular access to Gordon Town and surrounding communities, impacting the districts for more than a year.

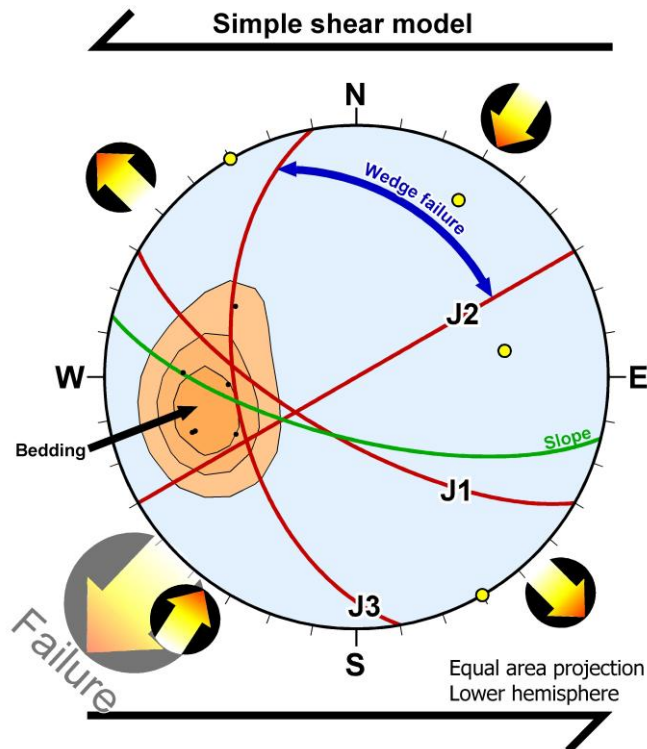
Figure 5. Equal area stereonet for Landslide L2 showing bedding (plotted as poles) and the three systematic joint/minor fault sets (plotted as great circles). The bedding is dipping to the ENE at a relatively steep angle, it is therefore dipping into the slope (green great circle). The three main joint sets (J1, J2 and J3) are shown as great circles. Small arrows show principal stress directions (extension and compression) associated with E–W sinistral simple shear that is characteristic of deformation in Jamaica (DeMets and Wiggins-Grandison, 2007).

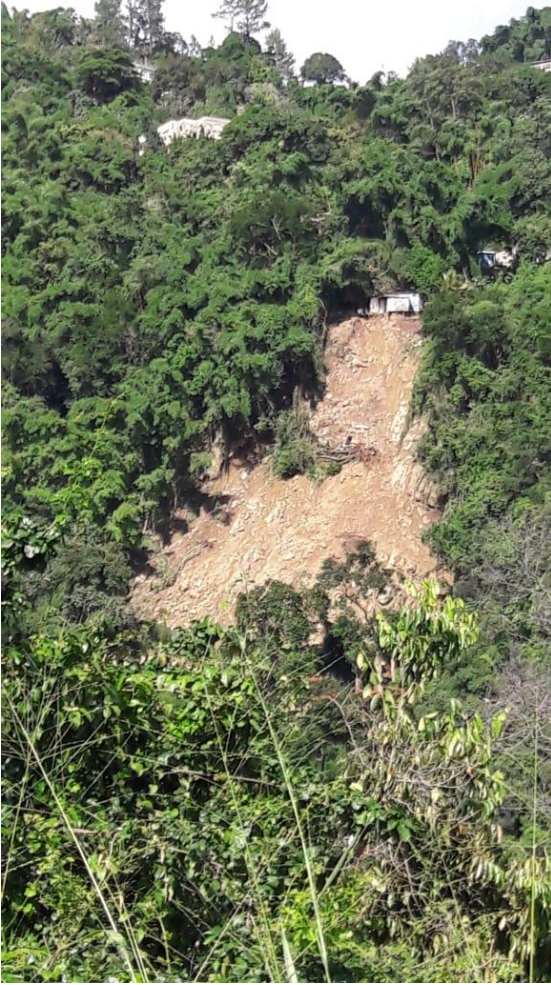
Figure 6. Landslide **L3**. This landslide occurred in a series of interbedded sandstones and shales of the Wag Water Formation. This is an area of folding and the sandstones and shales are dipping downslope towards the road (which is situated at the foot of the landslide). Photograph by **SFM**.

Landslide L3 (Figure 6). This occurred on the Irish Town Road at a major bend within a valley to the NW of the community of Wiltshire (18° 02.738' N, 077° 43.662' W). This landslide occurred in a unit of predominantly bedded sandstone, shales and thin limestones that form the core of a small anticline (Figures 2 and 6). Similar sedimentary rocks are exposed for a distance of about 1 km along the Irish Town Road to the SW of the landslide (Figure 2). The bedding in this unit is highly variable and forms an anticline plunging to the SW at the site of landslide L3 (Figure 7) and frequently dips down slope along the road to the SW. This landslide occurred in the bedded sandstone-shale sequence associated with an anticlinal fold dipping down the valley.

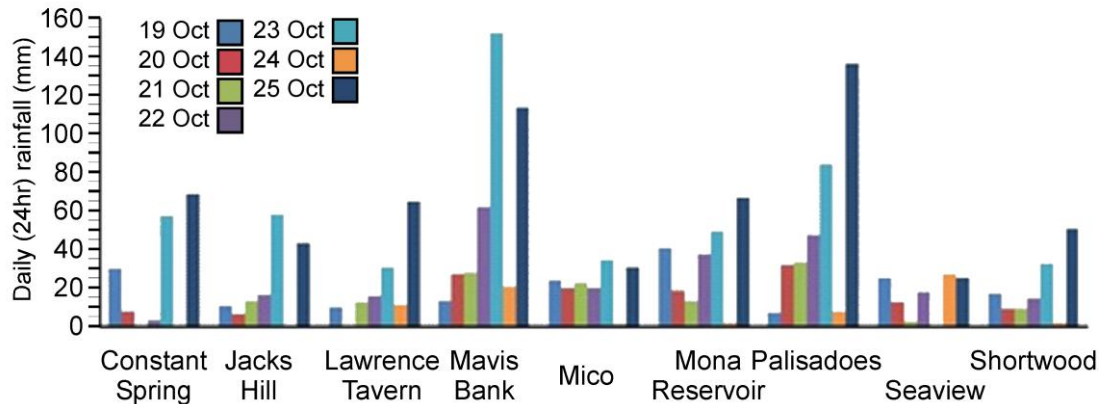
Figure 9. Daily (24 hr) rainfall recorded in the rainfall gauging stations of the Hope River Watershed and the parishes of Kingston and St Andrew for the period 19th–25th October 2020 during the passage of Tropical Storm Zeta.

Catherine and Clarendon). **Figure 9** shows the 24 hr (daily) rainfall associated with tropical storm Zeta for the 19th to 25th October sourced from the nine working stations. The station at Mavis Bank recorded peak daily rainfall of 151 mm and 113 mm on the 23rd and 25th of October, respectively. The station at Palisadoes/Norman Manley International Airport recorded a peak daily rainfall of 135 mm on the 25th of October. Rainfall declined after the 25th of October, with values falling to lows of 0 to 2 mm per day at some stations. The mean total rainfall using data from the nine stations that were active for Tropical Storm Zeta (parishes of Kingston and St Andrew) for the period 19th to the 25th October was 205 mm/station with the station at Mavis Bank recording a total of 415 mm over the duration of the storm.

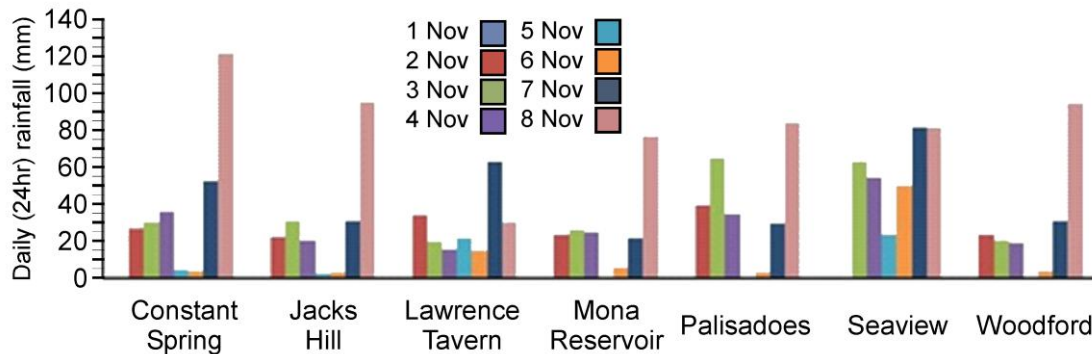
Figure 10. Daily (24 hr) rainfall as recorded in the stations of the Hope River Watershed and the parishes of Kingston and St Andrew for the period 1st–8th November 2020 covering the passage of Tropical Storm Eta.

Tropical Storm Eta followed closely after the passage of Tropical Storm Zeta and affect the island from the 1st to the 8th of November 2020. Intense rainfall was recorded in all of the rainfall stations with maximum daily rainfall of 121.2 mm recorded at the station at Constant Spring. The

mean total rainfall for Tropical Storm Eta for the seven stations (parishes of Kingston and St Andrew) was 237 mm/station. For the stations common to both events (Constant Spring, Jack’s Hill, Lawrence Tavern, Mona Reservoir, Palisadoes and Seaview), the total rainfall was 172 mm/station for Tropical Storm Zeta and 186 mm/station for Tropical Storm Eta.

All three landslides occurred on the same day (8th of November 2020) when daily rainfall associated with the passage of Tropical Storm Eta was greatest (above 80 mm for six stations: **Figure 9**), yet not as great as at some stations with the passage of Tropical Storm Zeta (when daily rainfall amounts exceeded 80 mm for two days each (21st and 23rd of October) at two of the stations (**Figure 8**). The landslides were, therefore, likely triggered by either antecedent rainfall or an episode of intense rainfall after antecedent rainfall (e.g., **Rupp, 2022; Nguyen et al., 2024; Liang et al. 2025**). Luckily, no earthquakes occurred during or shortly after the passage of the two tropical storms (UWI Earthquake Unit), and this was not a trigger for the landslides. If an earthquake had occurred, it is likely that significantly more landslides would have been triggered.
